## MEMORANDUM

**Re:** San Jacinto River Waste Pits TCRA Armored Cap Maintenance Completion Report

This document provides a summary of inspection, sampling, and maintenance activities completed on the armored cap installed as part of the Time Critical Removal Action (TCRA) at the San Jacinto River Waste Pits Superfund Site (TCRA Site). The TCRA was implemented by the Respondents, International Paper Company and McGinnes Industrial Maintenance Corporation (collectively, Respondents), under an Administrative Settlement Agreement and Order on Consent (AOC) with the U.S. Environmental Protection Agency (USEPA) – Docket No. 06-12-10, effective May 17, 2010 (USEPA 2010).

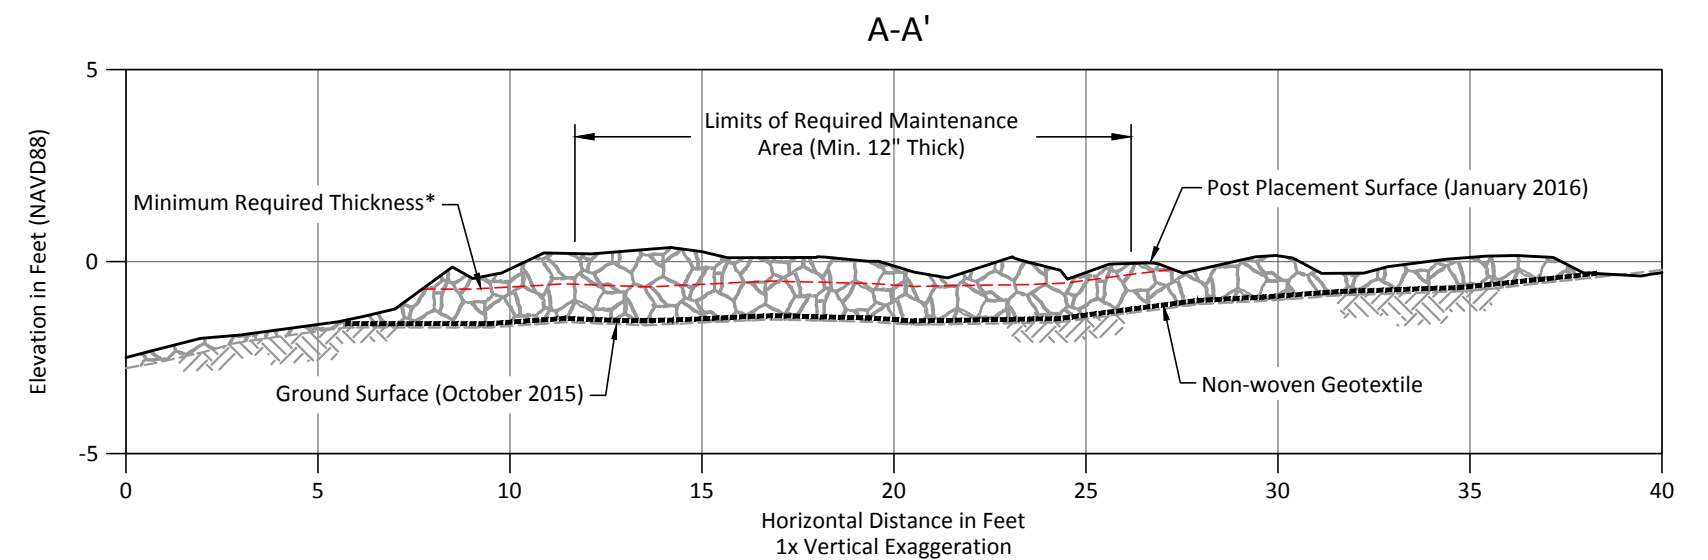
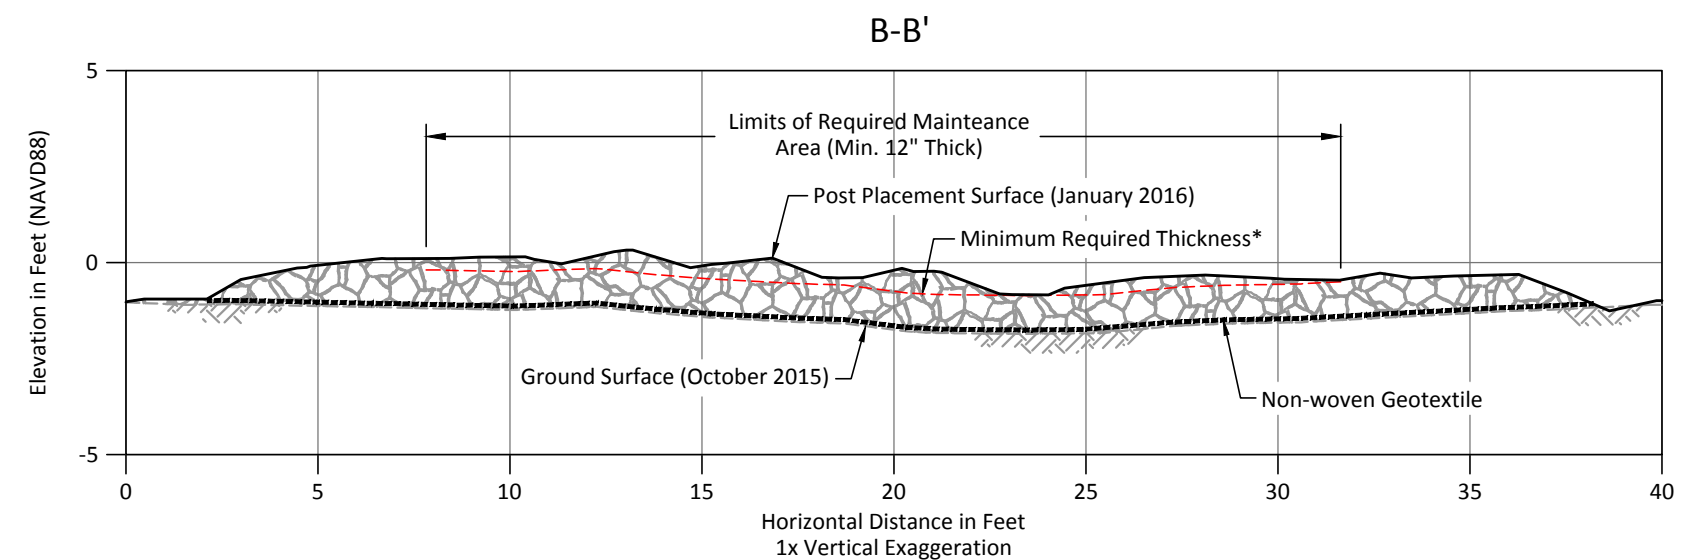
| Figure 1 | Armor Rock Placement Plan and Cross Sections |

Probing continued until no additional locations requiring that a PVC pipe be left in place were identified. Field personnel used a Trimble GPS to collect coordinates for a perimeter based on the PVC pipes placed during the probing to define an area shown in red on Figure 1 (Delineated Area).

Armored cap maintenance construction was completed on Monday, January 4, 2016, and a post-construction survey of the Maintenance Area was completed on the same date. Figure 1 shows the armor rock Delineated and Maintenance Area boundaries. The Maintenance Area boundaries extend 5 feet beyond the Delineated Area as specified by the Work Plan. The figure also contains cross sections of the Maintenance Area. Each cross section displays pre- and post-construction topographic survey data and a line depicting the 1-foot minimum required thickness.

\* Minimum thickness was field verified by probing.

The above steps ensured that the geotextile was placed with a minimum 5-foot overlap beyond the Delineated Area boundary in all principal directions. After the geotextile had been placed over the entire Maintenance Area, the long-reach excavator placed the full thickness of armor rock on top.

To confirm the required minimum 1-foot thickness of armor rock in the Maintenance Area, probing took place on December 31, 2015. Measuring tape was affixed to a metal probing rod, and the depth to the geotextile fabric and depth to the armor rock were recorded for each probing location. The difference between the two measurements is the thickness of the armor rock above the geotextile fabric. Table 2 lists the results from the confirmation probing. The initial probing indicated there were locations where additional armor rock was required to attain the minimum 1-foot thickness. Additional armor rock was placed in these areas, and probing was conducted again to verify a minimum 1-foot thickness was achieved.

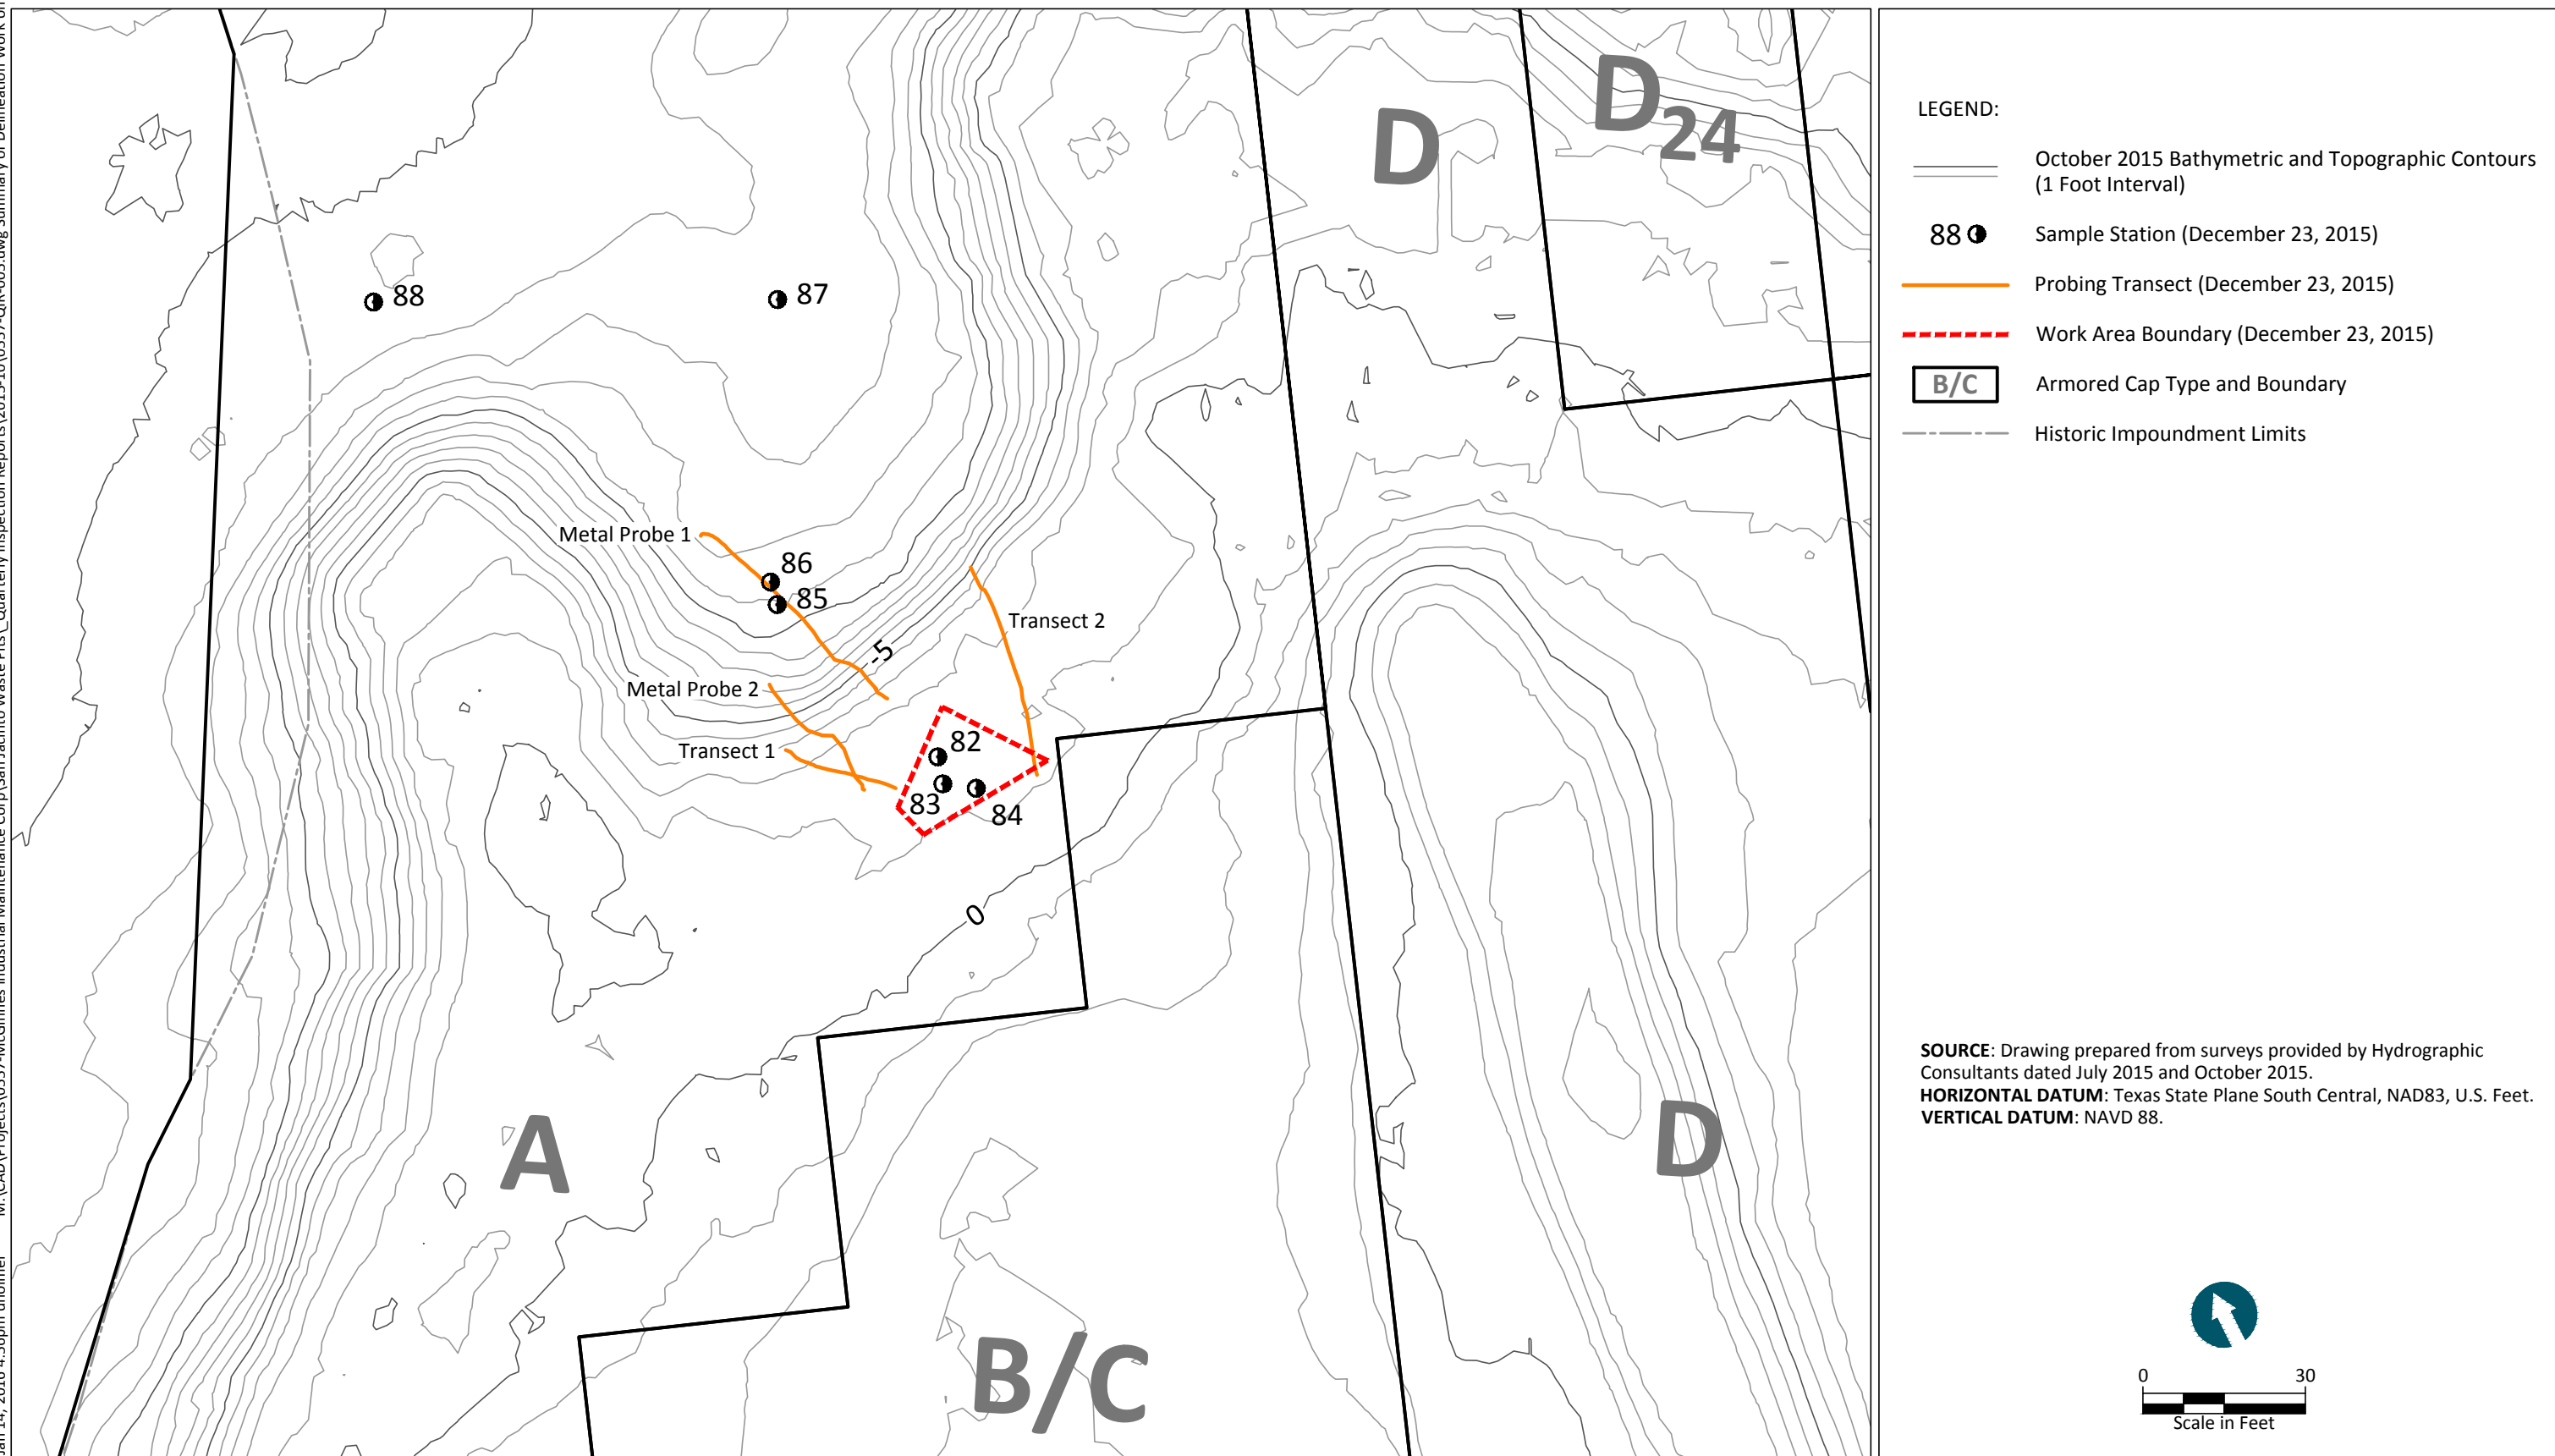
| Figure 2 | Summary of Delineation Work on December 23, 2015 |

Probes within the Delineated Area indicated cap material was present at varying thicknesses. The presence of an estimated minimum of 3 inches of armored cap material was confirmed at all locations probed within the Delineated Area. In some locations at which the PVC poles were placed, the estimated thickness of armored cap material detected during probing was greater than 3 inches.

Three sediment samples were collected for chemical analysis (including total organic carbon [TOC], percentage of moisture (%M), grain size, and dioxin/furans) from sample stations within the Delineated Area (Figure 2). A pole-mounted, 9-inch by-9 inch, Ekman sediment sampler was used to collect the sediment samples. The sampler collected materials in the top

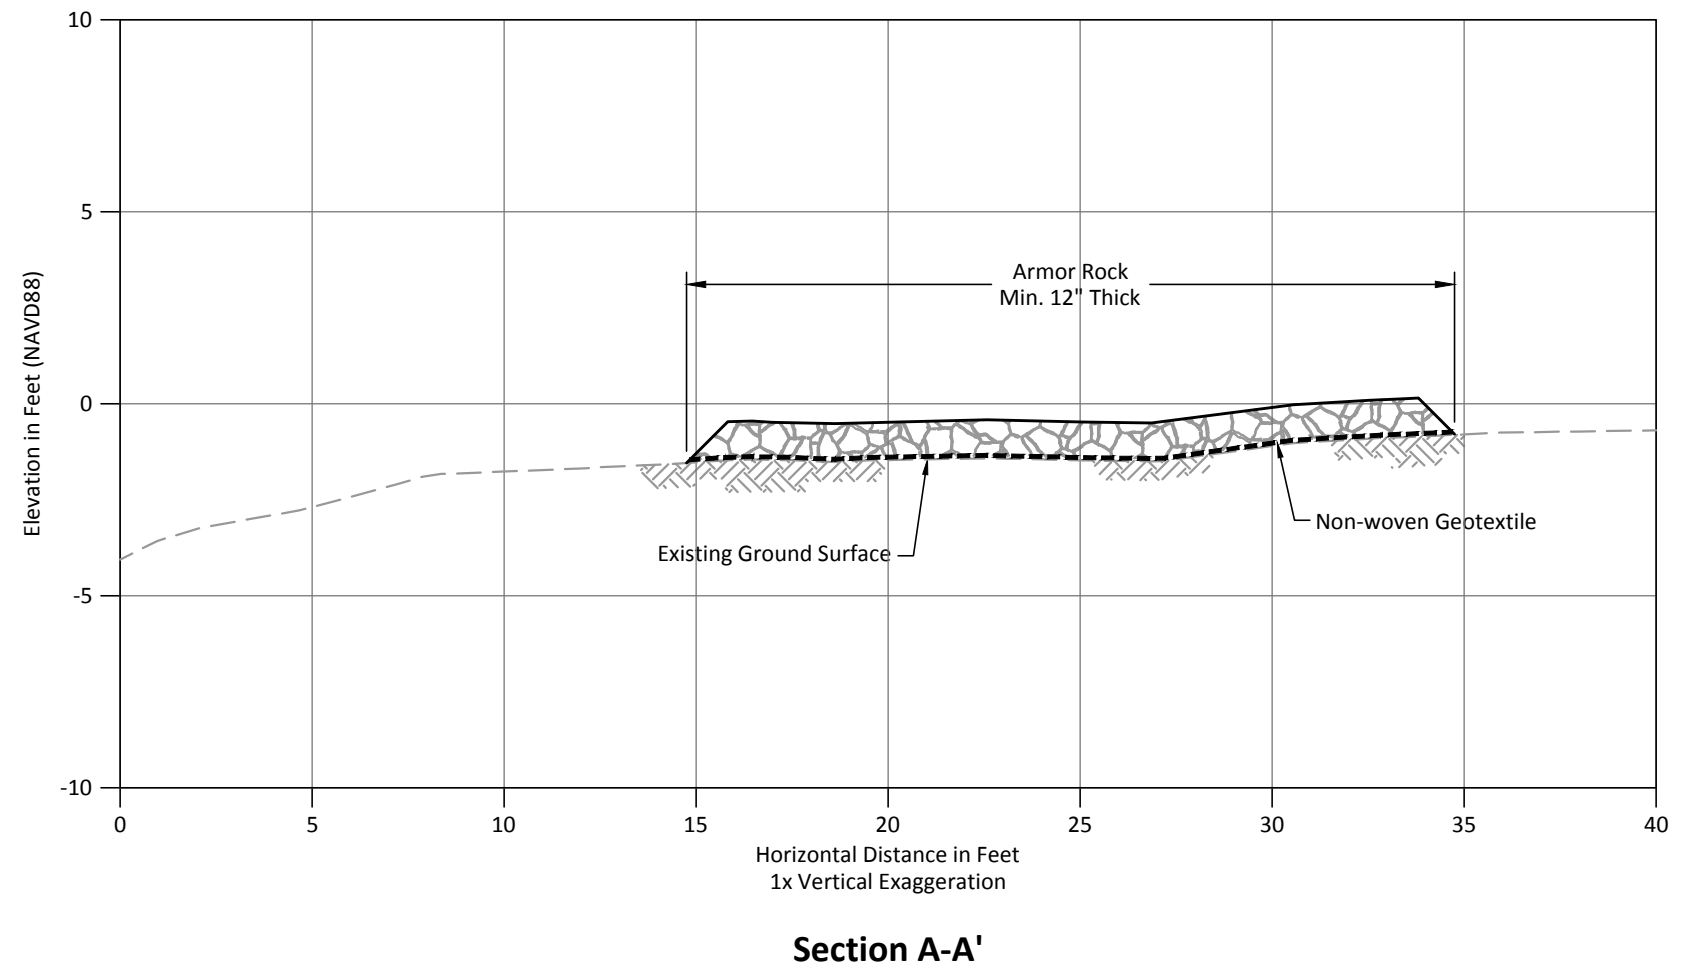
**Figure 2**  
Rock Placement Area  
Post TCRA Inspection  
San Jacinto River Waste Pits Superfund Site

The probing and sediment sampling during the delineation of the Work Area indicated that armored rock was present over the entire area; however, the cap material was intermixed with shells and soft sediment. The Work Area, shown in Figure 2, measured approximately 20 feet by 22 feet and was on the shelf above the slope that exists in the northwestern part of the armored cap. The water depth in the Work Area was approximately 8 to 18 inches at the time of the delineation and sampling. Areas outside of the Work Area were found to be a solid substrate of armor rock and shells that acted to bind the armor material together,

Because of the amount of cap material and the relatively large size of those materials, it was difficult to collect sediment samples within the Work Area; however, three samples were collected within the Work Area after several attempts under your supervision. Probes of the “shelf” between the damaged area and the slope showed that the area did not have a sediment accumulation that could be sampled. With your concurrence, four additional samples were taken from soft sediment accumulations on top of the armored cap material at the base of the slope below the damaged area and then further north (Figure 2).

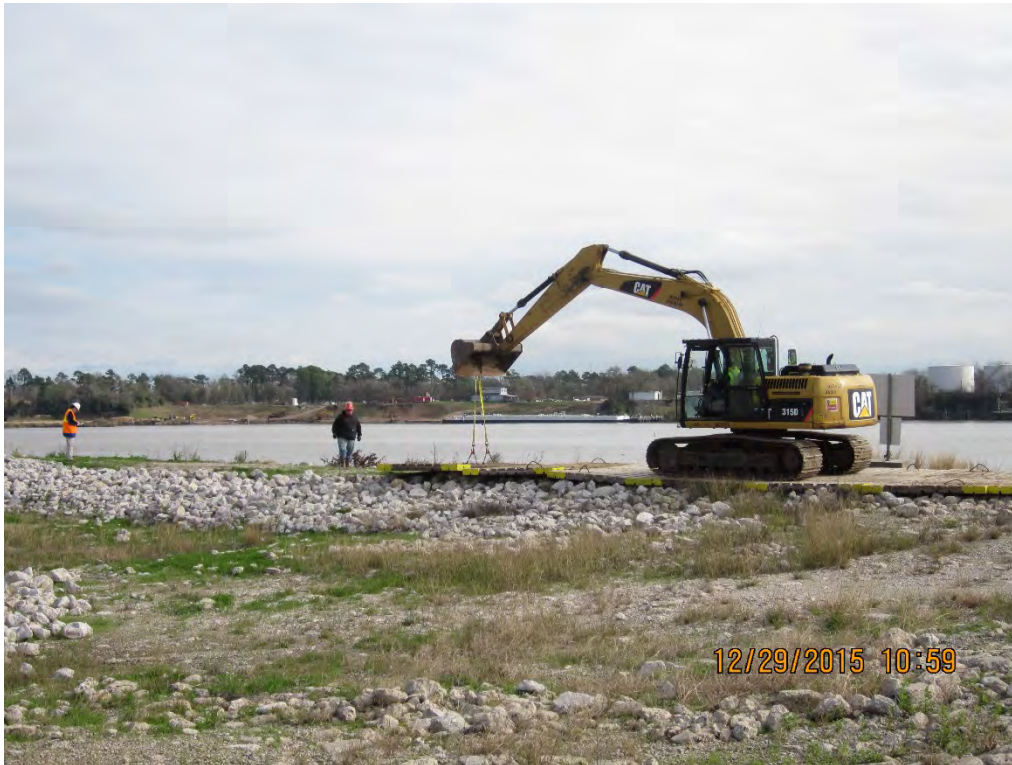
Photograph 2 – Excavator placing mats along central berm.

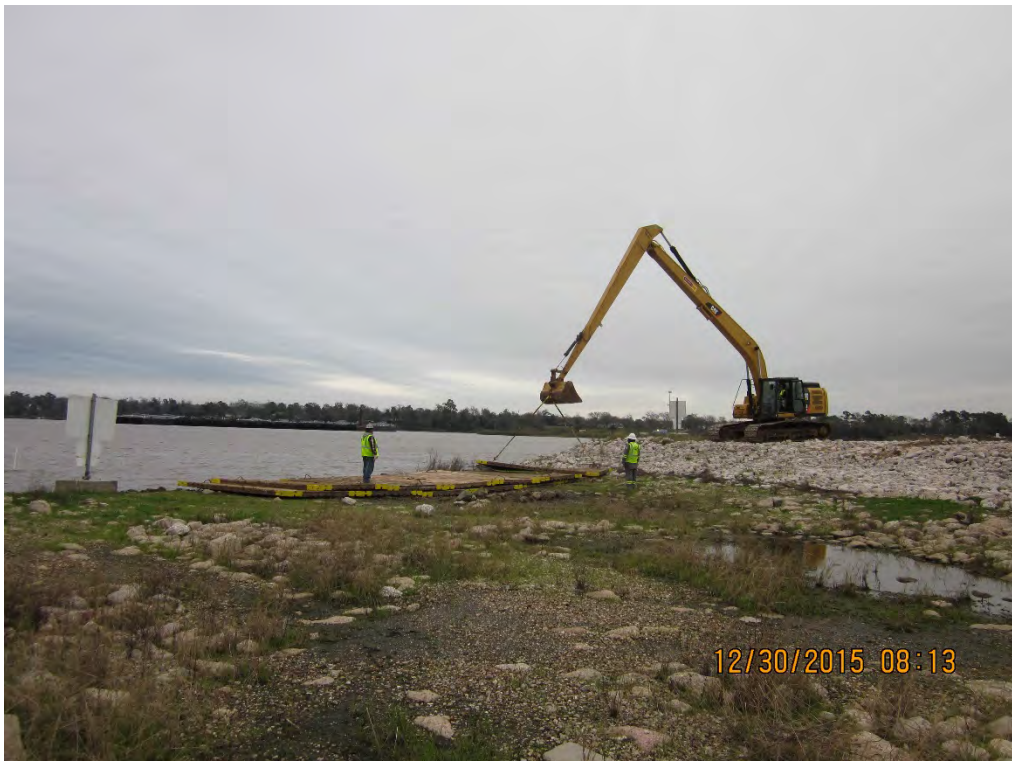
Photograph 1 – Assembling mats near work area as a base for the long stick excavator.

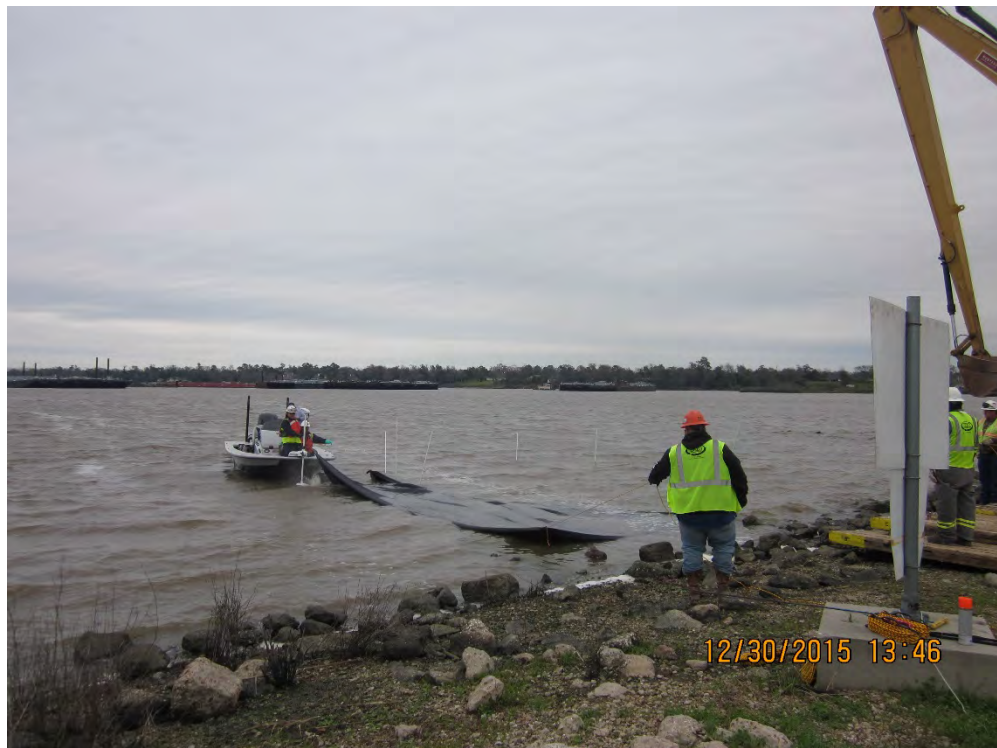
Photograph 3 – Placing geotextile over work area.

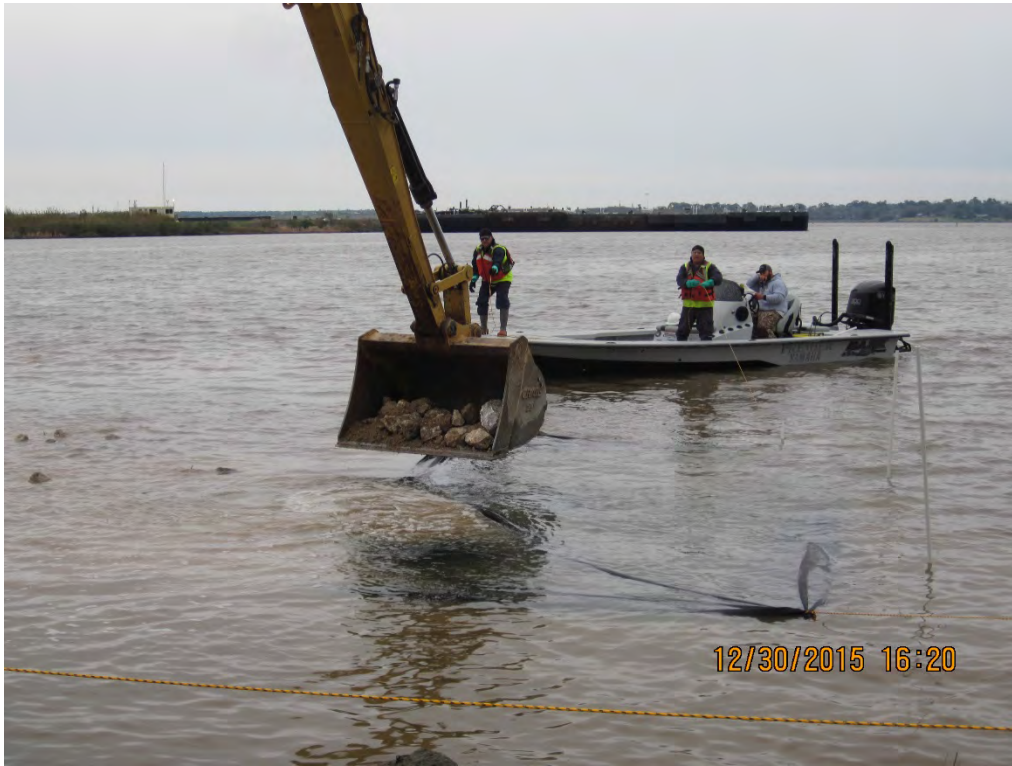
Photograph 4 – Placing Type C rock on top of geotextile layer in work area.

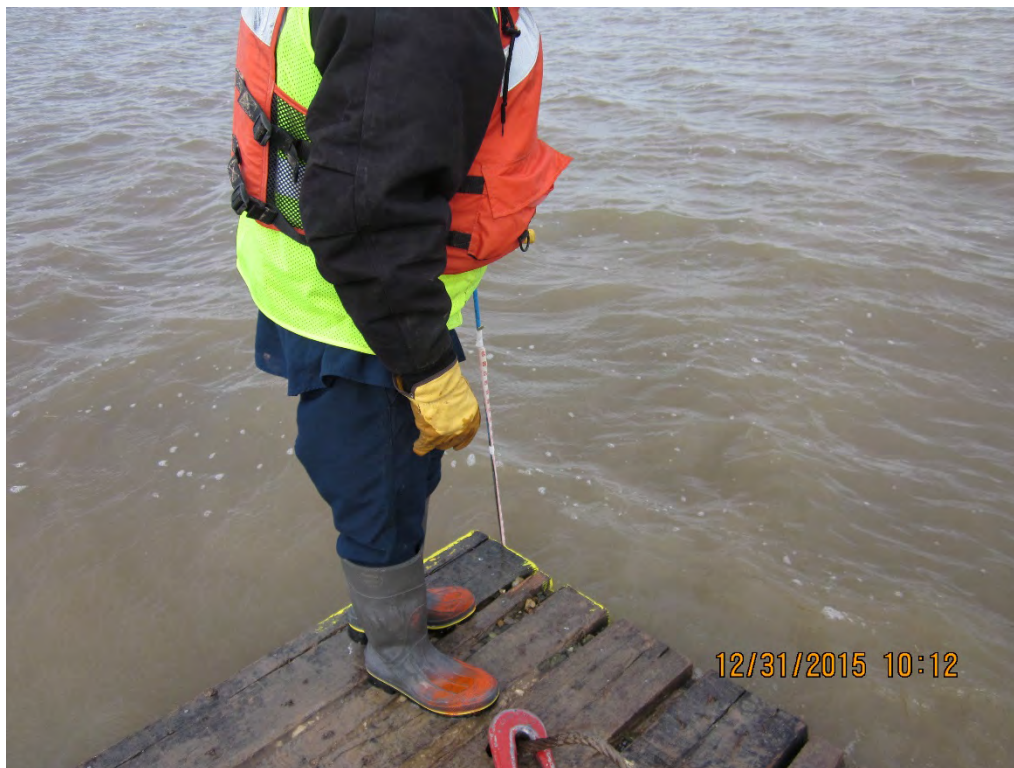
Photograph 1 – Probing for thickness of armor rock in repair area.

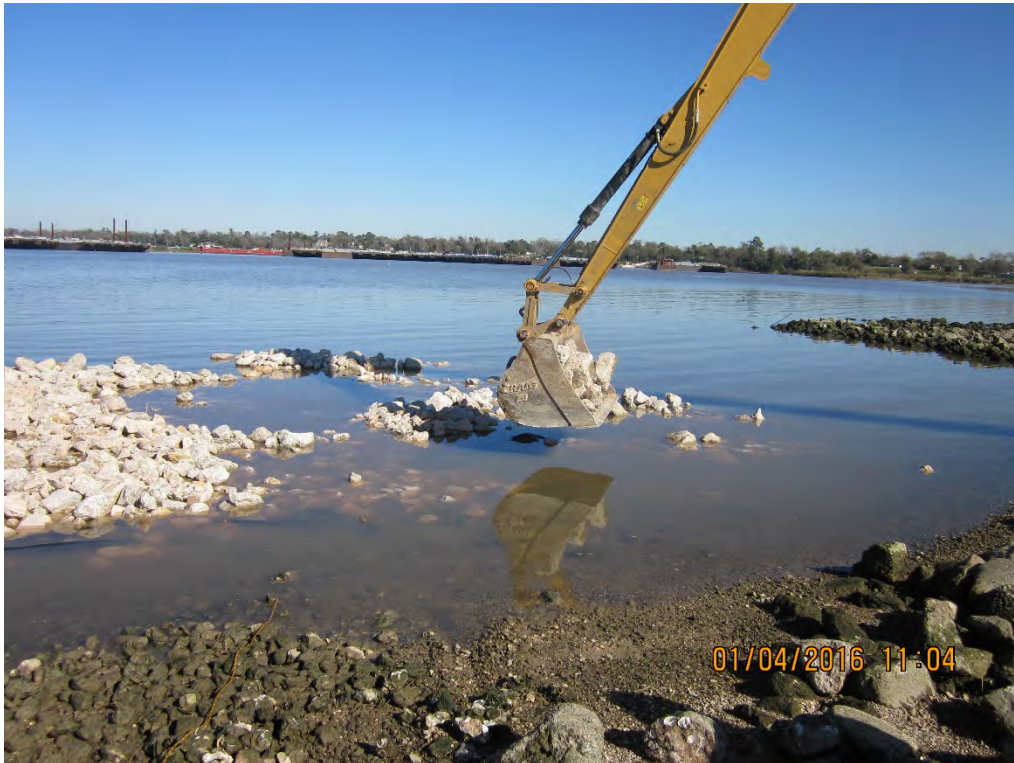
Photograph 2 – Addition of armor rock to areas with exposed geotextile seen during low tide.

0920 – H. Samaha observed work area during low tide. Recently placed geotextile was exposed along southern portion of work area. Anchor QEA and USA plan to cover exposed geotextile areas with additional Type C armor rock stockpiled at the Site.

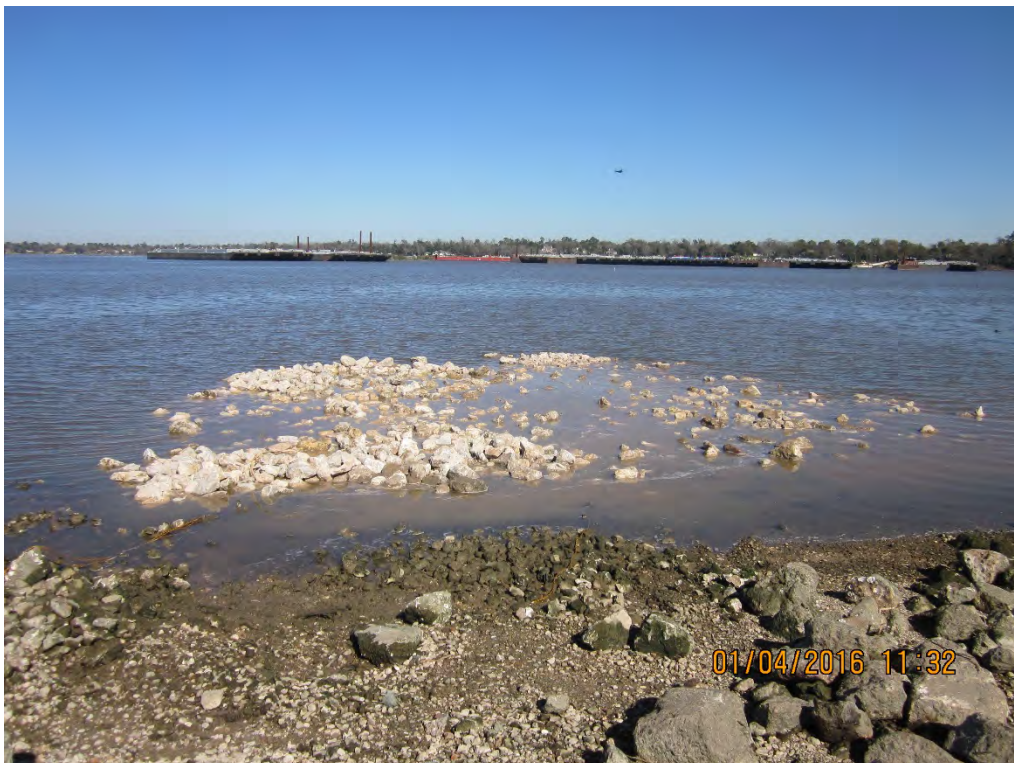
Photograph 3 – Work area during low tide after maintenance was complete.
